PASSAIC RIVER BASIN
WANAQUE RIVER, PASSAIC COUNTY
NEW JERSEY

LAKE INEZ DAM

NJ 00228

**PHASE 1 INSPECTION REPORT
NATIONAL DAM SAFETY PROGRAM**

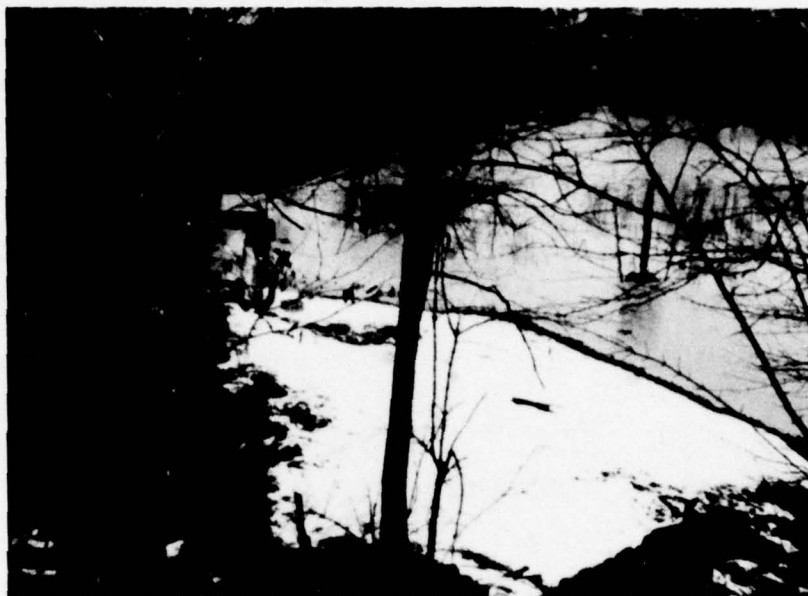
The left side of the dam is founded on rock and a deposit of soil has formed a beach on the upstream side at the left abutment. (Photo 1)

Photo 1
View of left abutment of dam looking west

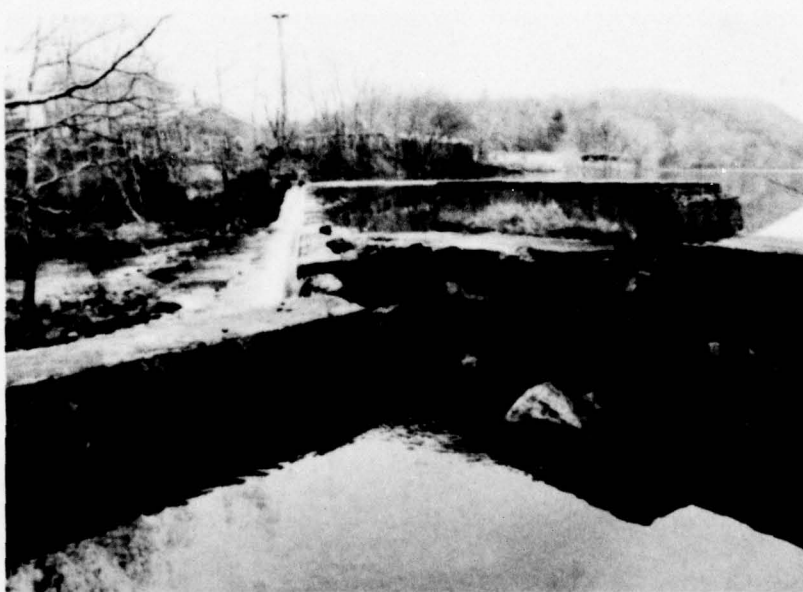
Severe cracking and separation between the concrete cap and masonry were observed at the junction of the left side of the spillway and the dam (Photo 2). Water from the reservoir is leaking through these cracks at an estimated rate of 5 gpm, forming a pond 6 to 12 inches deep. (Plate 2). There is a notch in the left side of the dam approximately 2 feet deep and 6 feet long which may have been associated with the penstock which appears to pass beneath the dam at this location.

Photo 2
View of left spillway abutment looking west

(3) The cracks adjacent to the left spillway abutment should be repaired to eliminate the leakage.

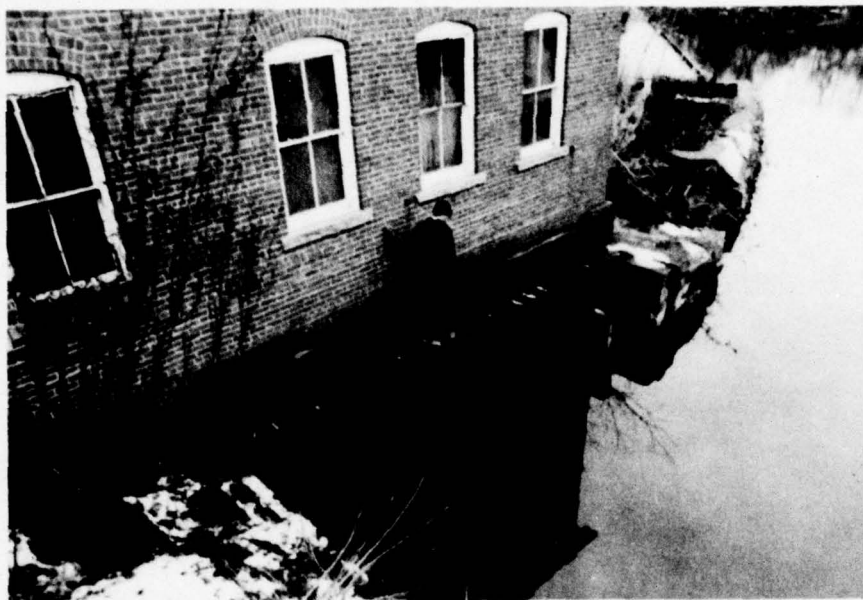
At the right abutment, the foundation of a mill building acts as part of the dam (Photo 3). A raceway which originally passed through the mill has been sealed with concrete bricks. The rubble masonry foundation of this building on the downstream side has been severely eroded (Photo 4). The erosion is most severe on the east side adjacent to the sluiceway and particularly at the downstream corner of the building. A minor amount of seepage through the foundation of this building was also observed.

Photo 3
View of mill at right
abutment of dam looking east

(2) The foundation of the mill should be repaired and seepage through the foundation should be sealed off.

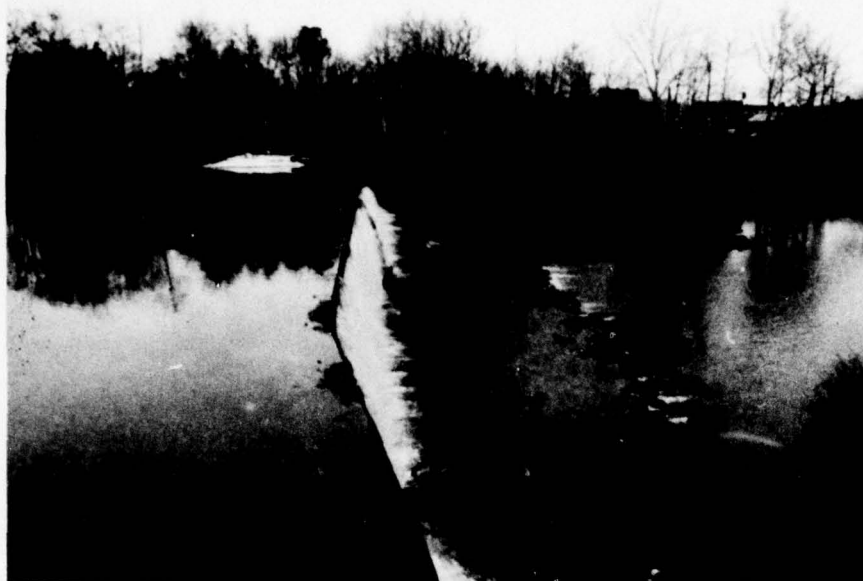
A concrete apron extends 10 to 15 feet downstream from the dam. (Photos 5 through 7) The foundation of the spillway and apron were submerged and therefore could not be observed.

Photo 5
View along spillway crest
looking towards left abutment

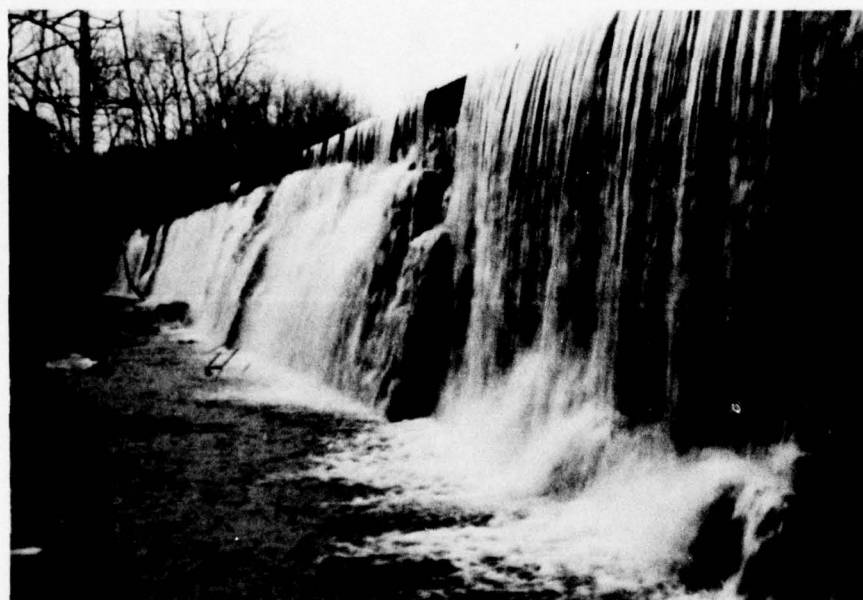
Photo 6
View of spillway face
looking west from left abutment

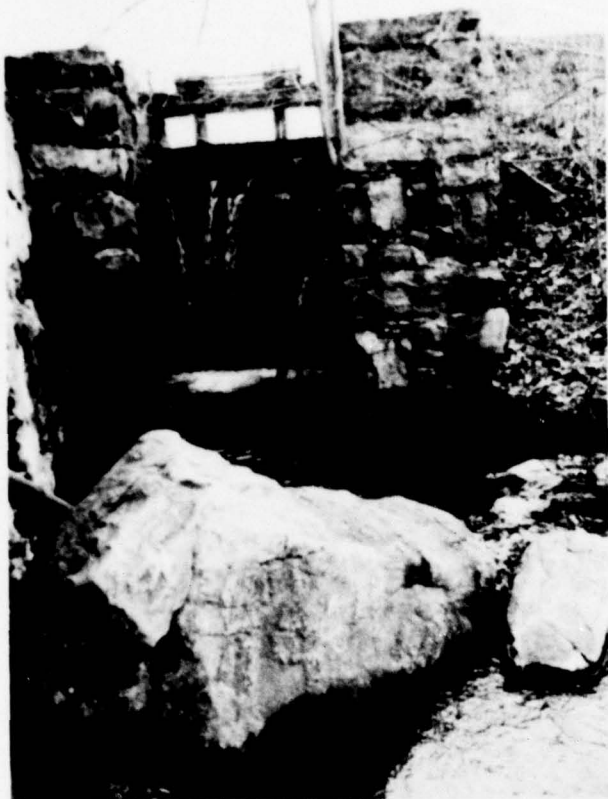
A 9.4-foot wide sluice gate consisting of 4-inch by 8-inch boards is located to the left of the mill at the right side of the dam. The gate controls are inoperable and there is serious leakage between the boards (Photo 9). A small tree growing in the masonry wall adjacent to the sluice is shown in Photo 9. The discharge from the sluice flows adjacent to the old mill and joins the main channel downstream as shown in Plate 2.

Photo 9
View of sluice gate
looking upstream

(1) The present wooden sluice gate should be replaced by a suitable means of control which can be operated from the dam crest.

(6) The trees adjacent to the sluice gate should be removed and the area restored in order to prevent root damage.

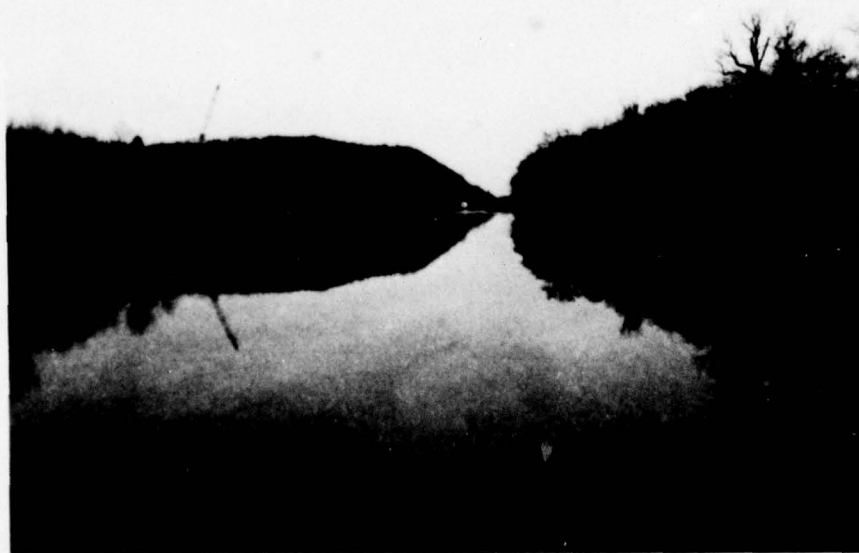
Photo 10
View of reservoir looking upstream from dam

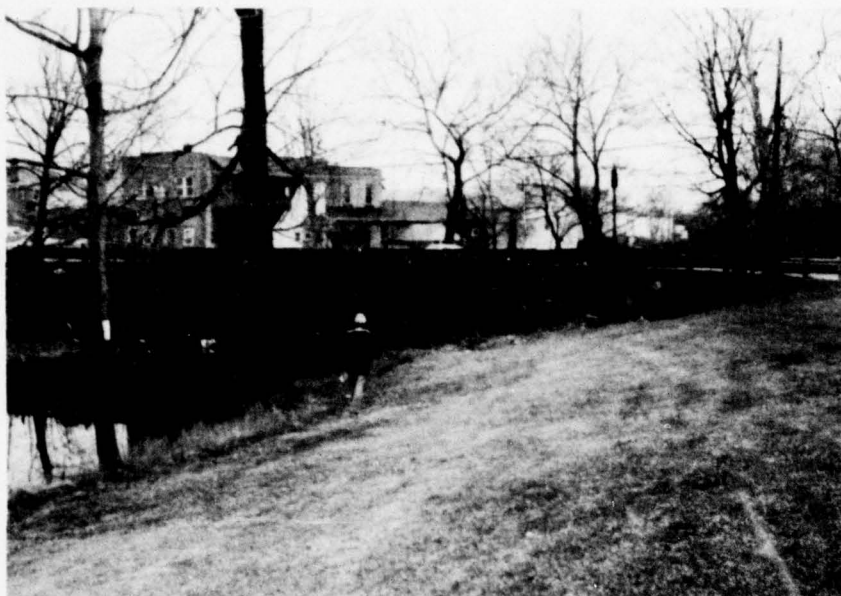
Photo 11
View of road bridge and
Borough of Pompton Lakes downstream from dam

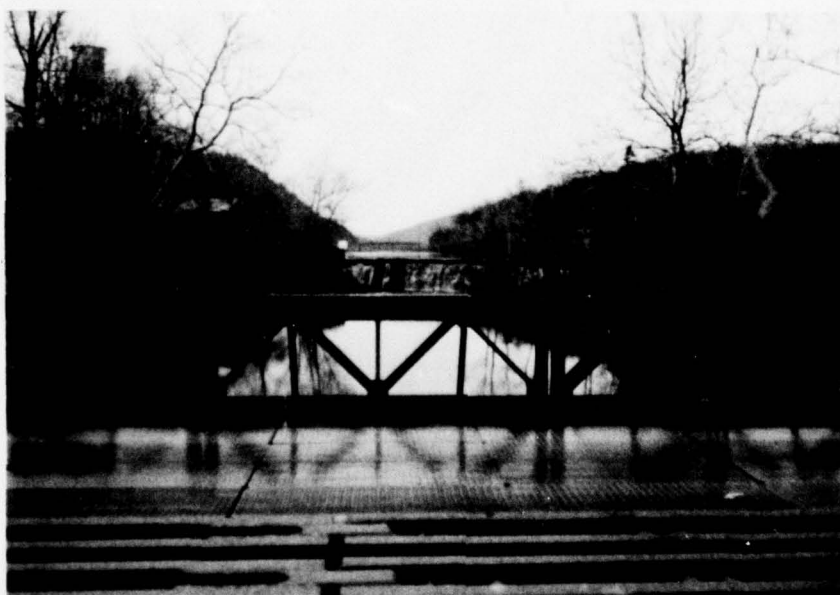
Photo 12
View of dam looking
upstream from bridge shown in Photo 11
